## **DAM SAFETY INSPECTION REPORT**

**OTSEGO DAM  
ID #00619  
SW 1/4 SEC 17. T1N, R12W  
KALAMAZOO RIVER  
ALLEGAN COUNTY**

**INSPECTION DATE:** April 16, 2004

**REPORT DATE:** July 12, 2004

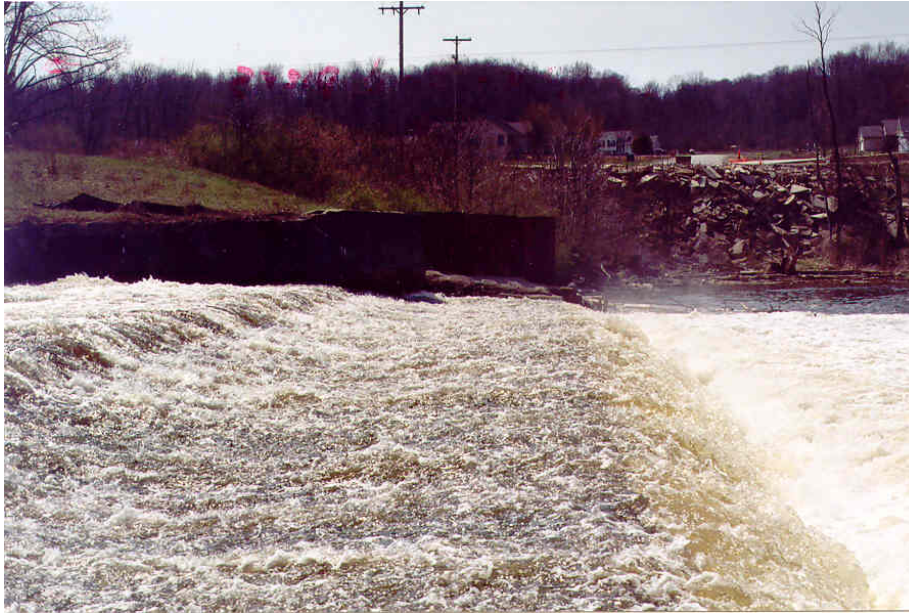
View of Left Training Wall

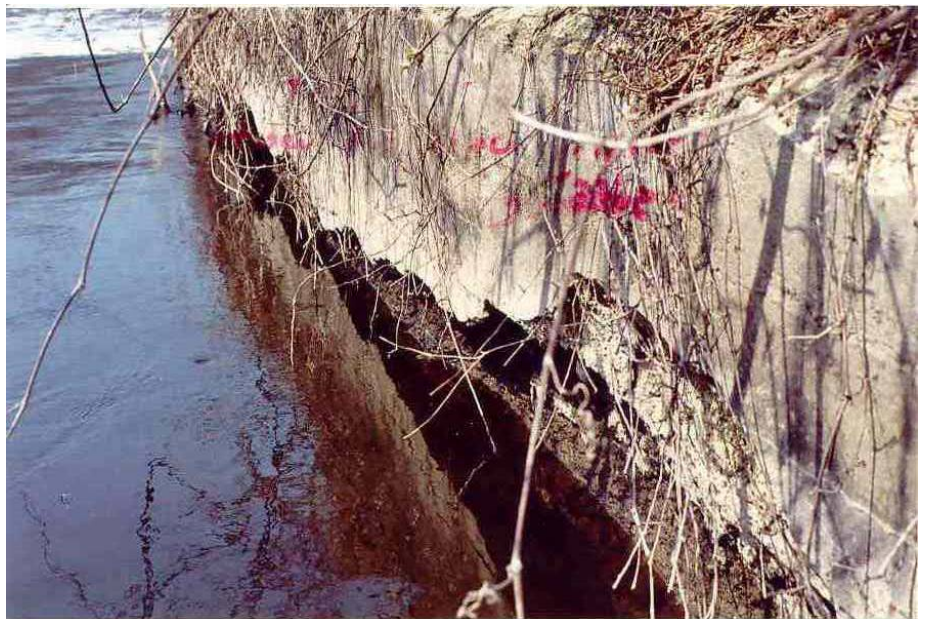
- The training walls are spalled in numerous locations and the upstream end of the right training walls is eroded to a depth of about 1-1/2 inches at the normal water level.

Erosion and Deterioration of Right  
Training Wall

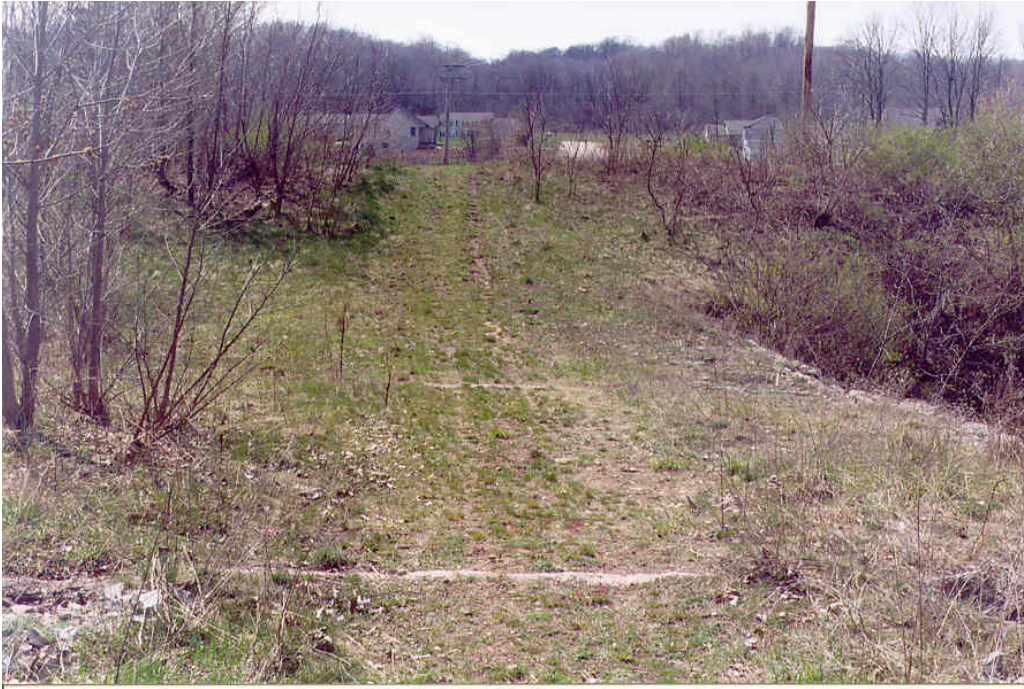
- The area around the former powerhouse is low and continues to be an area overtopped during storm events. While not leaking at the time of this visit, recent visits during higher pool conditions have shown slight leakage through the embankment at the former powerhouse location. Continuing uncontrolled leakage could cause internal erosion of the embankment, ultimately leading to dam failure.

Powerhouse Area on Right Embankment

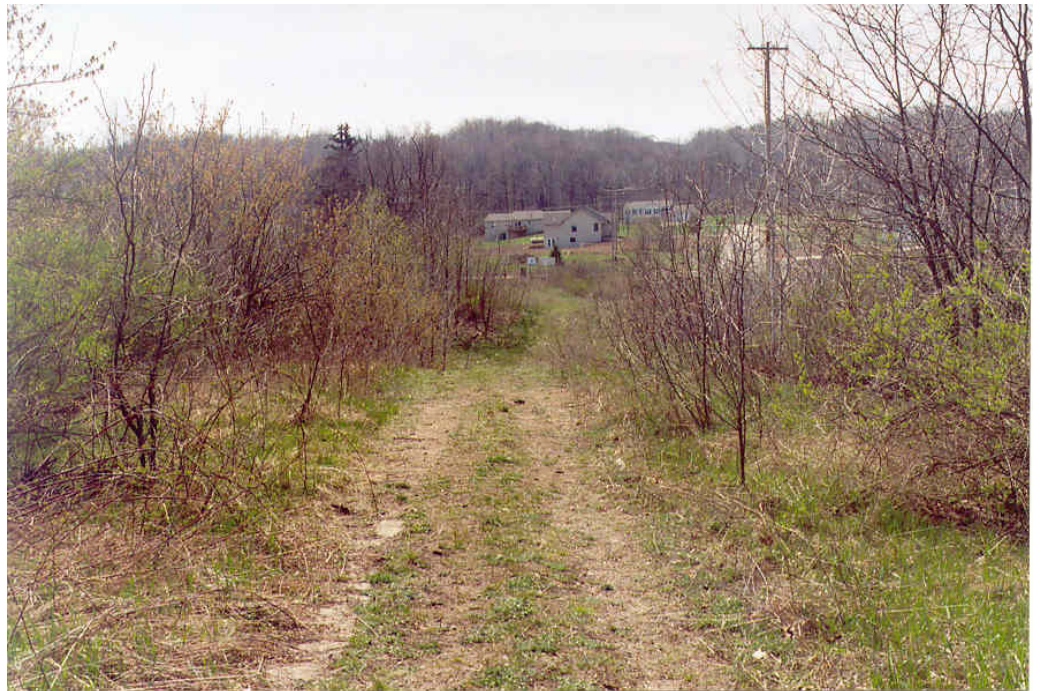
Right Embankment at Former Island

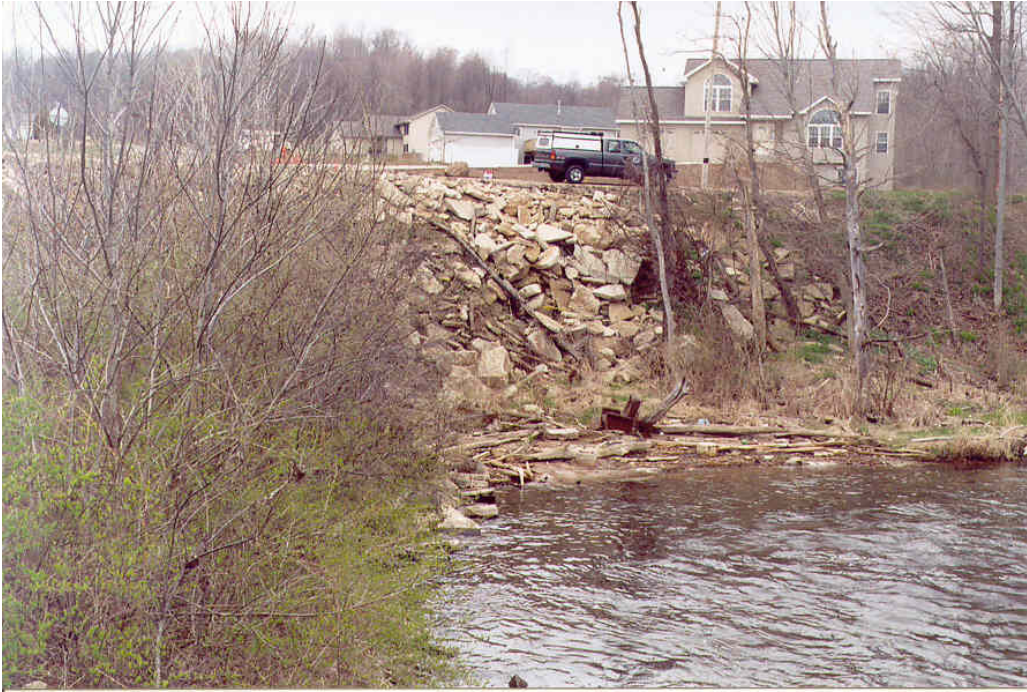
Rubble on Left Downstream Abutment

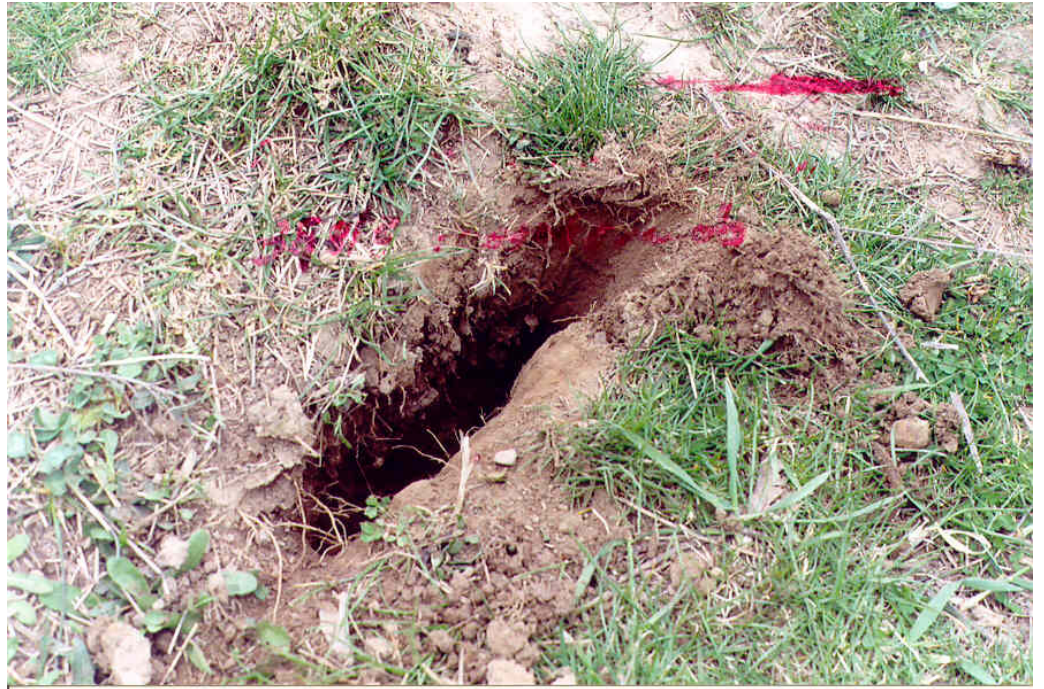
- Cracks in the soil, near the downstream end of the left training wall, indicate a scarp forming all the way to the ground surface over the voids created from the internal seepage erosion.

Scarp found Next to Sinkhole at Downstream end of Left Training Wall

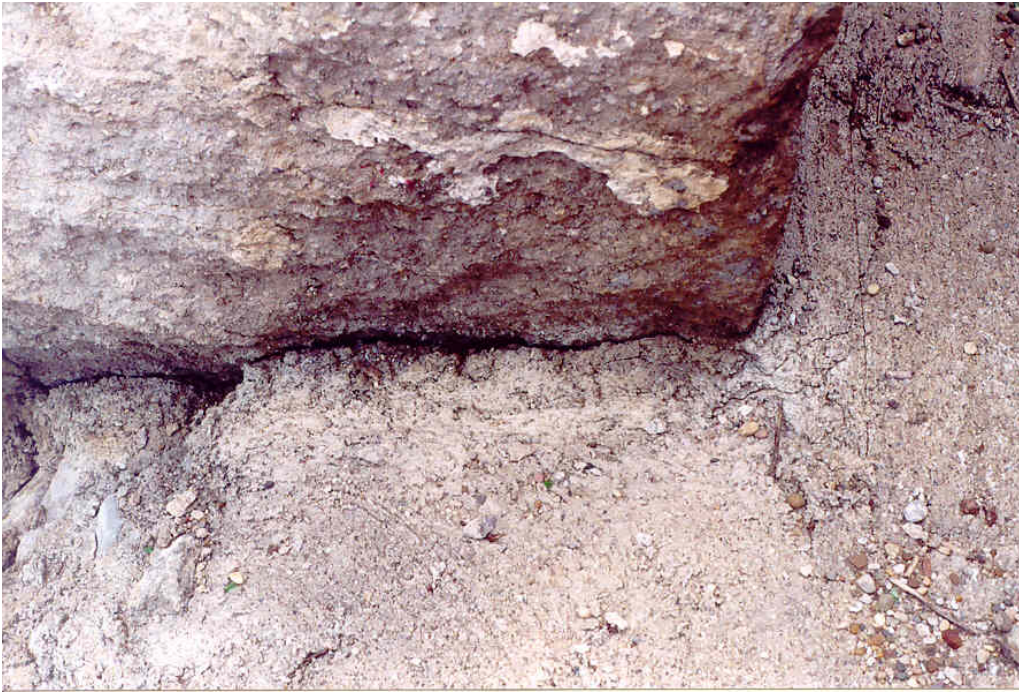
- Slight movement of the left training wall is believed to have occurred based on a small, recent, slight separation between the wall and the grout backfill placed around the wall at the time of the 2001 repairs.

Crack indicating Wall Movement

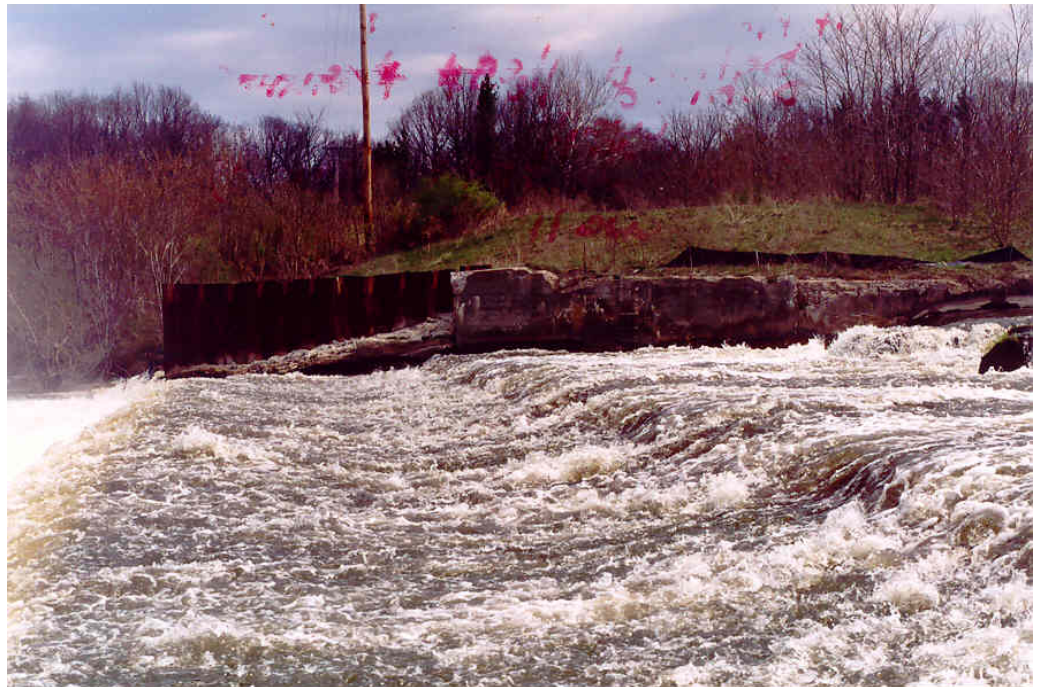
View of Right Training Wall

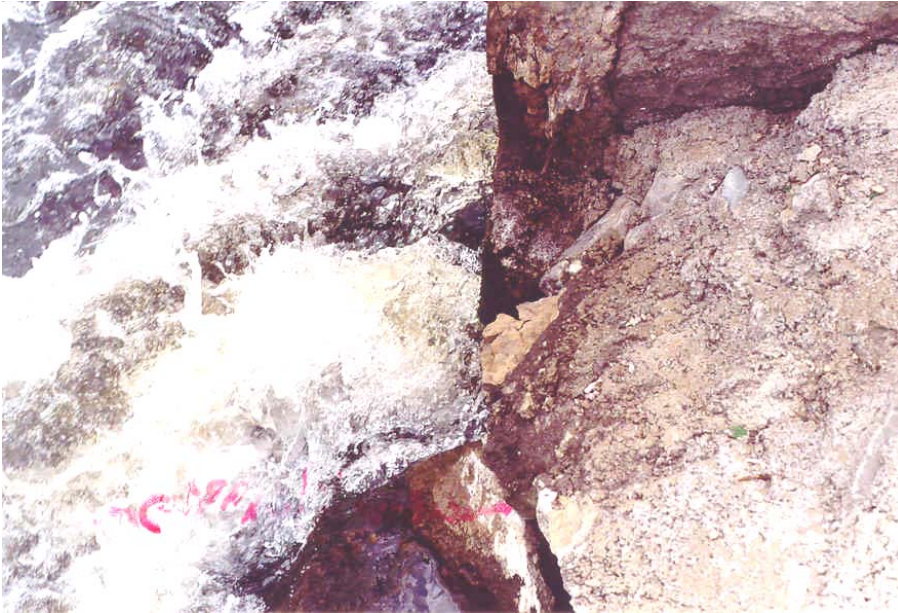
- Seepage through the wall on both the left and right sides confirm the flow of water behind the walls.
- A crack previously observed in the middle of the lower apron appears to have grown. The crack, which can only be seen during very low flow conditions, seems to have increased from about 1/2-inch in width to about 1-1/2 inches in width near the left training wall. A section of the apron about 4 square feet in area is missing from the downstream right corner of the lower apron.

Outflow of Water from behind Left Training Wall

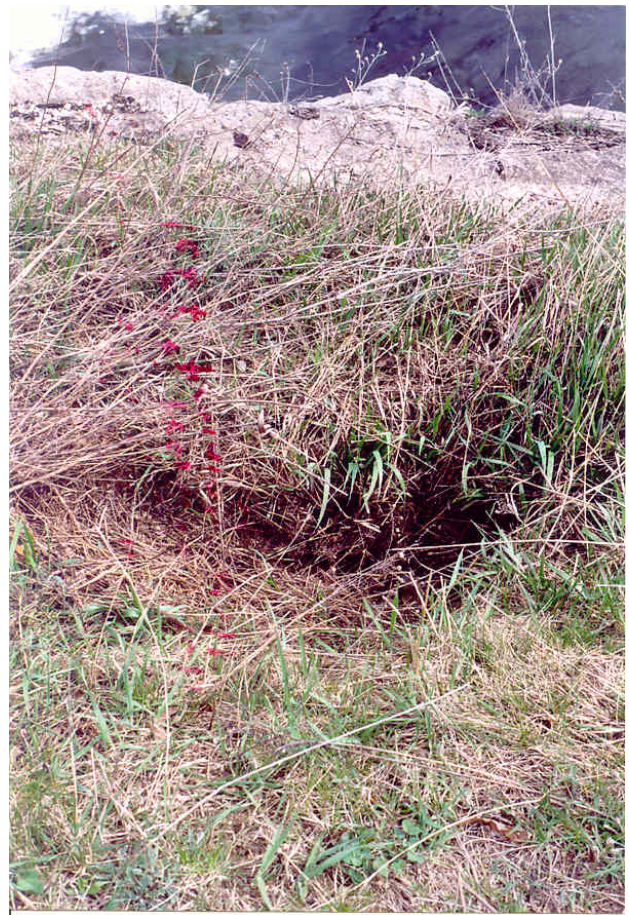
- Sinkholes continue to form along the back side of both the left and right training walls. The sinkholes have grown in size substantially since the last visit indicating increasing seepage below or behind the walls and continued failure of the cutoff walls below the dam.

Sinkhole next to Left Training Wall
